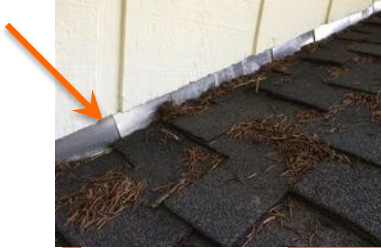
Roof Installation:		
Shingles appear relatively new installation, very nice job		
Chimney:		
Masonry construction in good condition		
Flashing:		
Flashing exposed under eave above front door and around chimney, may allow moisture intrusion into the home structure recommend siding contractor.

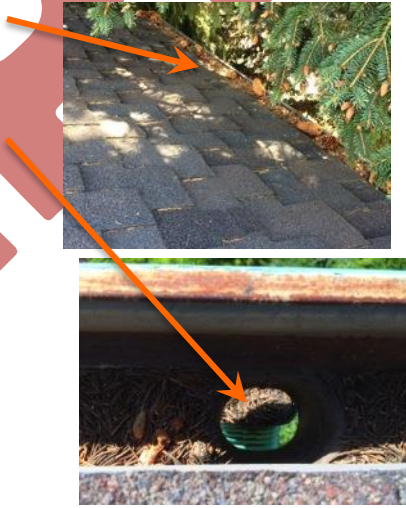
X
Presence of Mildew on Roof:		
None Observed		
Shingles Missing or Damaged:		
None Observed		
Gutters and Drainage:		
<ul style="list-style-type: none"> -Gutters on the west side of building clogged with debris. This can allow moisture to penetrate home as well as shorten the service life of the gutters. Recommend gutter-cleaning contractor. -Disconnected drain spout on northwest side of building allowing water to shower directly from roof to the ground. This could allow moisture and seepage into the home's foundation. Recommend further evaluation by a qualified gutter contractor. -Splashguards at base of gutters insufficient to deposit water 5 feet from foundation of house. This could allow moisture and seepage into foundation. Recommend further evaluation by a gutter contractor.

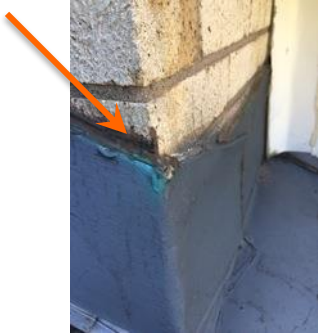
Flashing, type and Condition:		
<ul style="list-style-type: none"> -Mixture of old and new aluminum flashing. -Weather seal on older flashing at chimney appears to be beginning to fail, recommend evaluation by a roofing contractor or handyman.
